Damage and Degradation of Optics and Sensors under intense EUV radiation from a table-top LPP source

F. Barkusky, A. Bayer, C. Peth, K. Mann

Laser-Laboratorium Göttingen e.V.
Hans-Adolf-Krebs Weg 1
D-37077 Göttingen

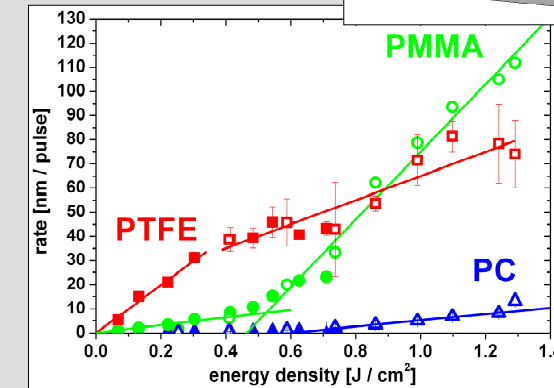
Polymer ablation

Energy density in focus

- ▶ Energy → calibrated photodiode
- ▶ Area → etching in PMMA

1.2 J/cm² (filtered by Mo/Si + Zr)

7.4 J/cm² @ 13.5 nm, 8.8ns (filtered only by Mo/Si)

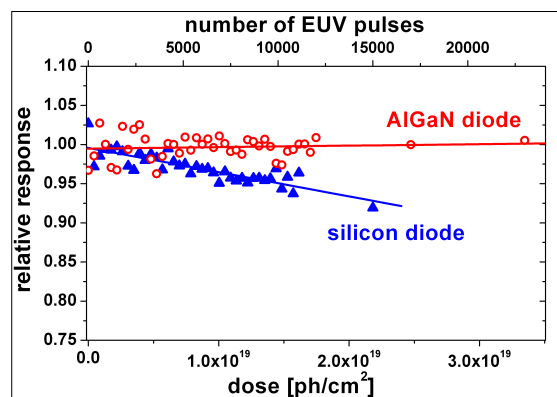
Radiation damage resistance

- ▶ Silicon diode
 - responsivity decreases
 - 8 % after 2.2×10^{19} ph/cm²
- ▶ AlGaN diode
 - no change in responsivity after 3.2×10^{19} ph/cm²

⇒ **Application: reference monitor for EUV**

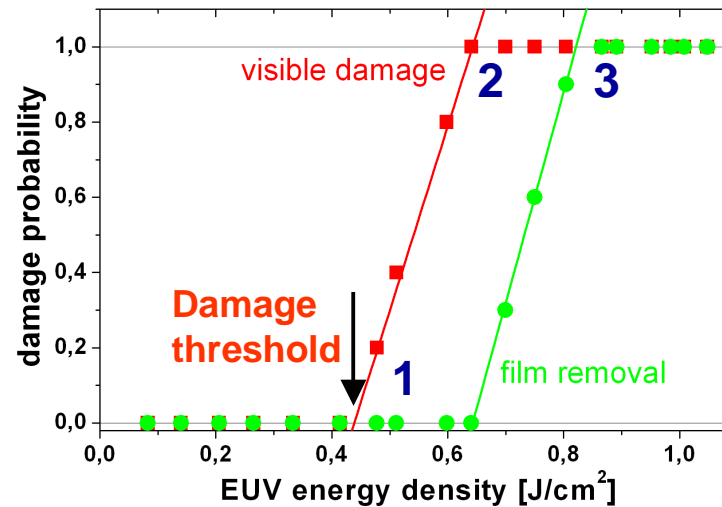
AFM-images, 10 μm x 10 μm

69 nm Au thickness

- ▶ Gold layer on glass
- ▶ 1-on-1 damage test
 - 10 positions, fixed fluence
 - damage probability plot

- ⇒ **damage threshold 420 mJ/cm²**
(69nm Gold film, 13.5 nm wavelength, 8.8ns pulse duration)
- ⇒ **Indication for thermal behaviour**

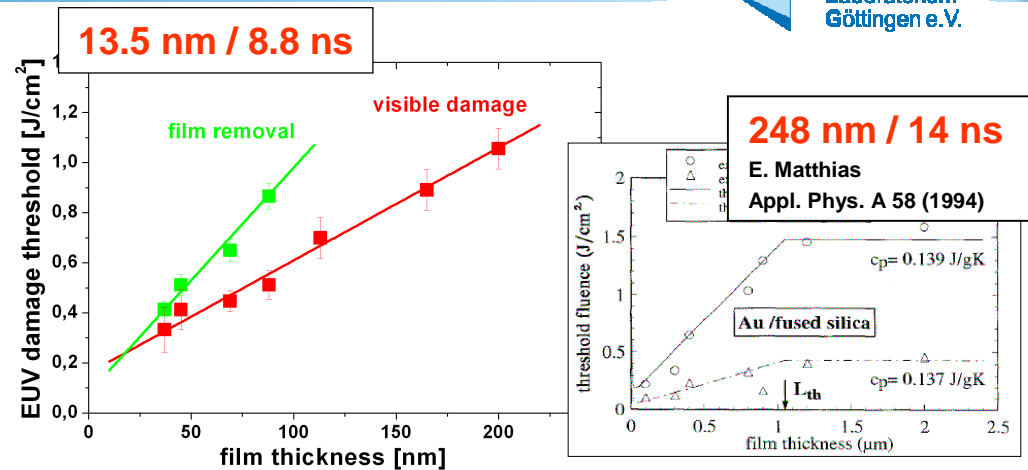
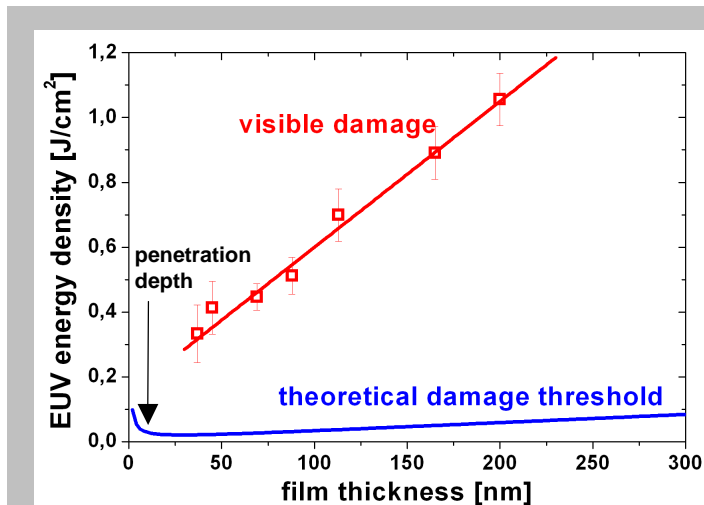
Varying Gold film thickness

- ▶ Film thickness dependence
 - Threshold fluence \propto film thickness
 - Different slopes for damage and removal
 - Offset 0.1 - 0.2 J/cm²

⇒ comparable to
Excimer-laser ablation

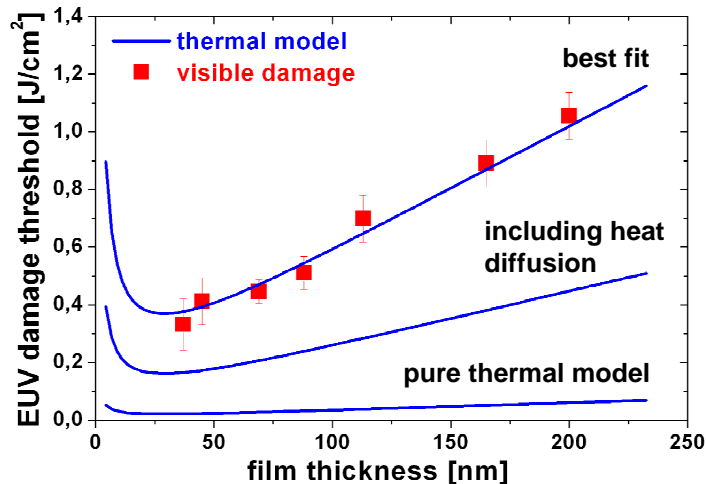
Correction of EUV energy density

▶ Heat diffusion during EUV pulse

⇒ Heat diffusion length ~ 1.9 μm (14 ns; 1/e²)
 (effective radius of EUV focus ~ 2.3 μm)

- ▶ better agreement to simulation
- ▶ remaining errors
 - partial loss of EUV energy
 - photo electrons (~ 10 %)
 - Photo - Fluorescence
 - Properties of film differ from bulk

⇒ data support thermal model for Au ablation @ 13.5 nm

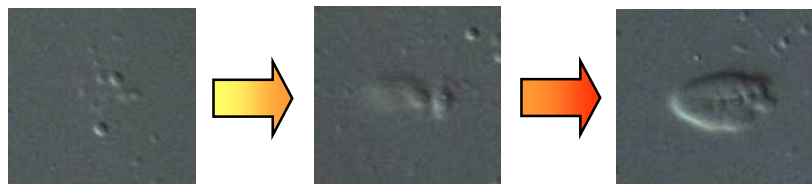
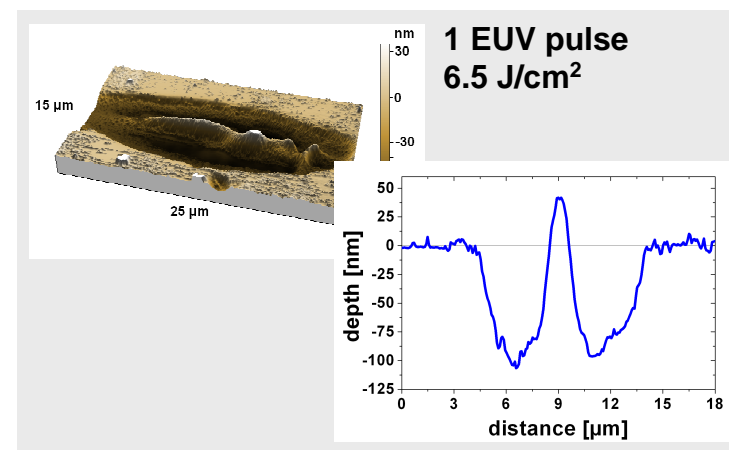
⇒ **high fluence: crater depth ~100 nm**
(1/4 of multilayer thickness)

⇒ **complete damage of multilayer system**

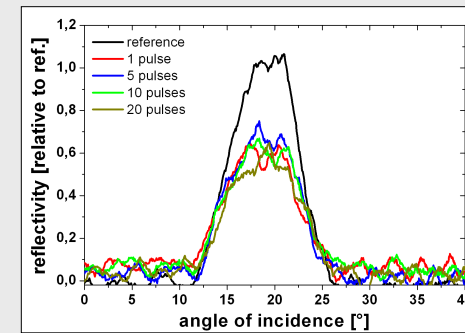
One-crater damage
(3.1 J/cm^2)

⇒ **Drop of reflectivity**

- no reflectivity on damaged area
- Damaged crater area increases with fluence
